WATER PUMP TECHNICAL SUPPORT BOOK

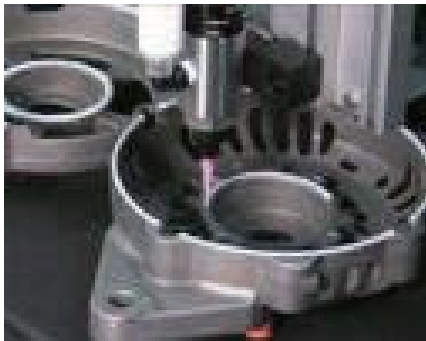
■ Liquid gasket applicator

In the production line, stringent control on the application amount is implemented by the use of components including an FIPG applicator.

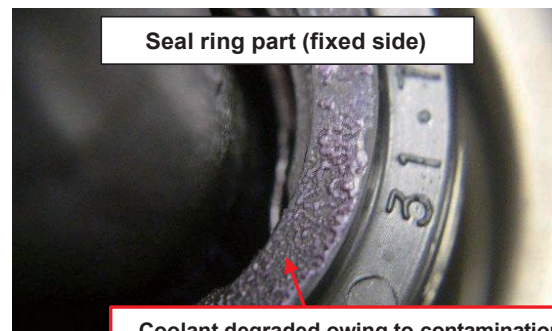
(1) Coolant contamination

- If cleaning is not sufficient or the coolant is not replaced in its entirety, contaminants such as dust, sludge, and sand in the coolant path can be caught onto the mechanical seal sliding surface (seal surface), and coolant may leak from the drain hole resulting from a loss of sealing performance.

Mating ring part (rotating side)

Seal ring part (fixed side)

Coolant degraded owing to contamination

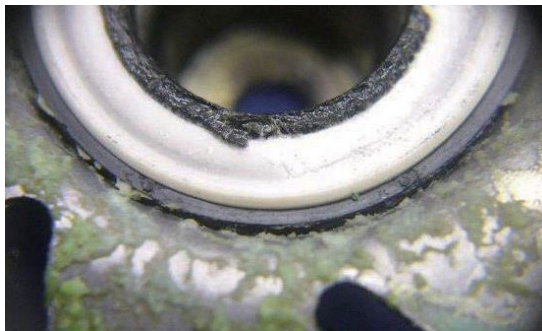
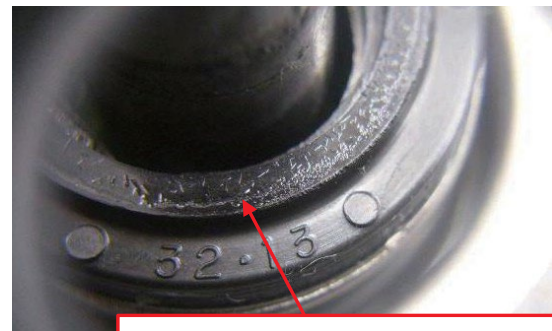
Travel distance: 5,000 km

Coolant degraded owing to contamination

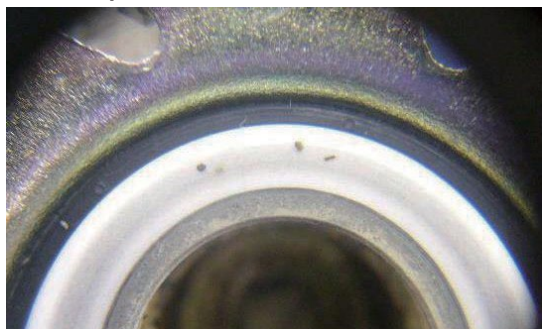
(2) Contaminant biting in mechanical seal

Contaminant biting

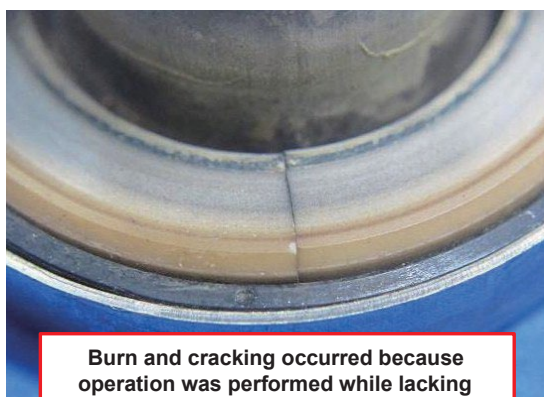
(4) Burn and cracking of mating ring

Burn and cracking occurred because operation was performed while lacking coolant after coolant level became low.

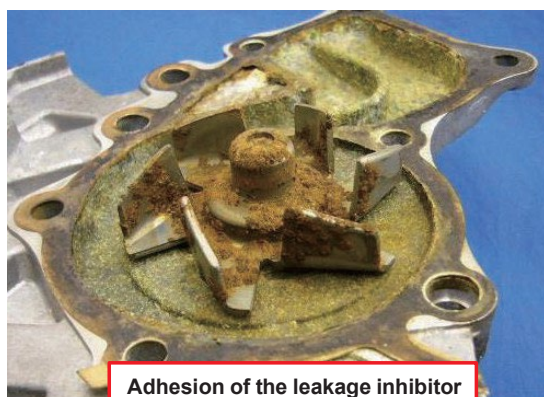
(5) Other (charging of leakage inhibitor)

Adhesion of the leakage inhibitor to the pump chamber

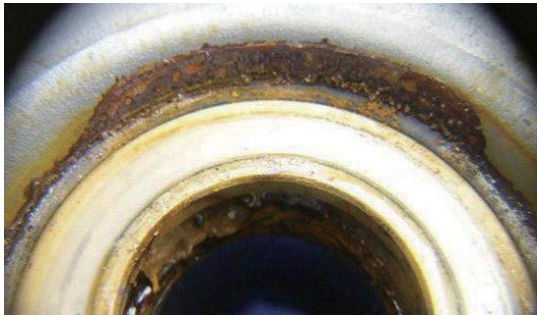
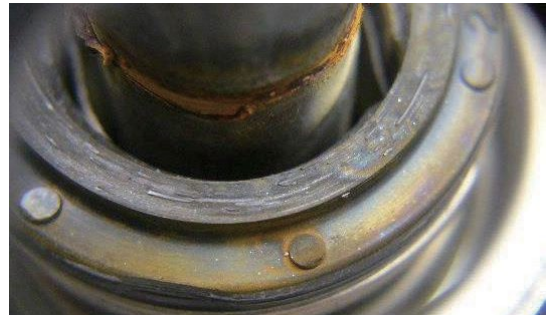
(1) Rust biting in mechanical seal

- Metal corrosion can generate biting contaminants, such as rust, in the mechanical seal sliding surface (seal surface), ultimately causing coolant leak from the drain hole.
- Propagation of metal corrosion and ***cavitation** can lead to coolant leak resulting from pitting as well as to overheating resulting from a loss of impeller.

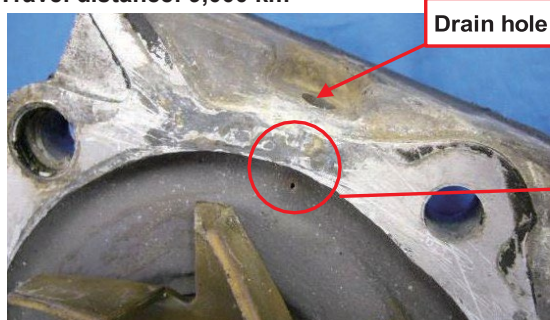
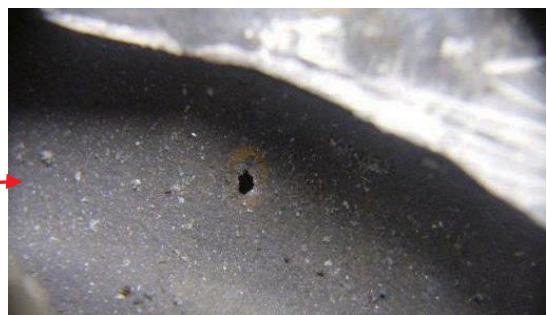
(2) Pitting in the body (through the hole reaching the drain hole and resulting in coolant leak)

Drain hole

Occurrence of erosion by cavitation

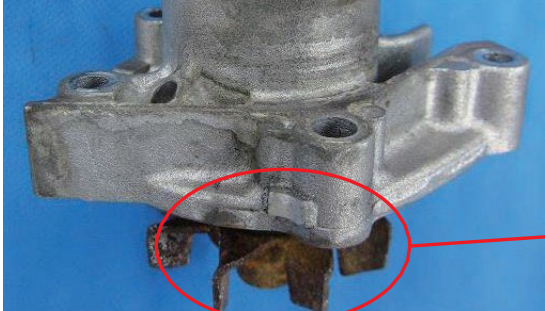
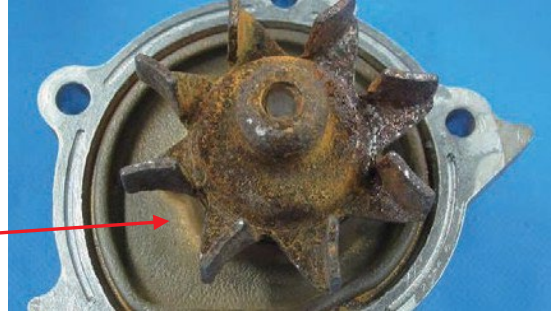
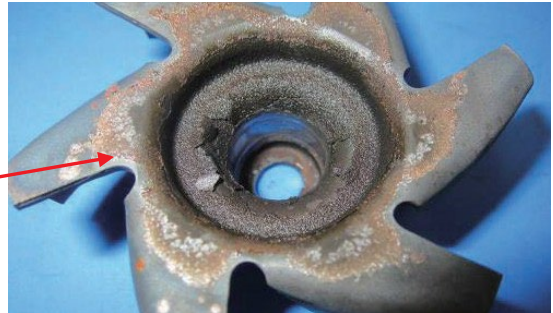
(4) Rust occurrence with the impeller Occurrence of corrosion and rust

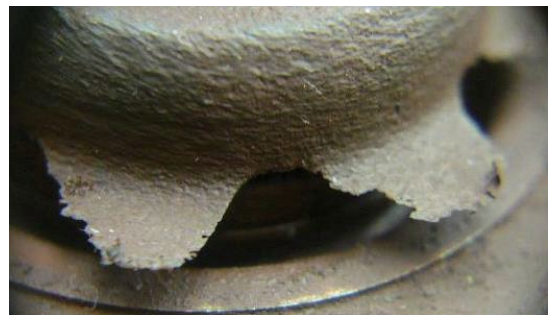
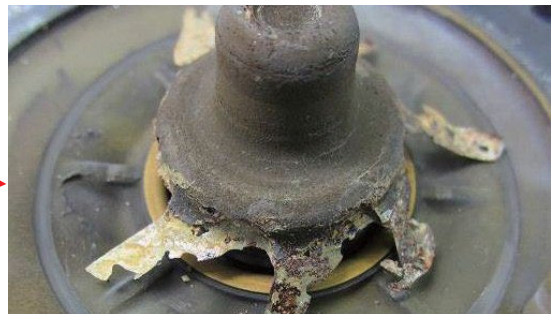
(5) Impeller corrosion and loss Occurrence of erosion by corrosion and cavitation

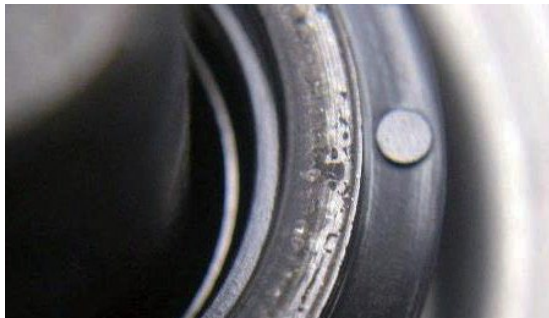
- (1) **Carbon transfer onto sliding surface** Components of the seal ring (fixed side) transferred to mating ring (rotating side)
Travel distance: 0 km

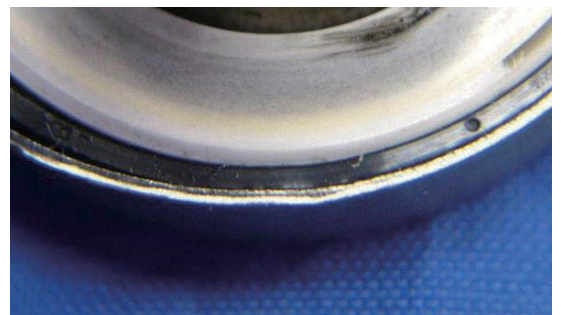
- (3) **Uneven contact of sliding surface** Increase in surface pressure occurred at a seal surface portion due to seal surface lubrication fault, etc.
Travel distance: 0 km

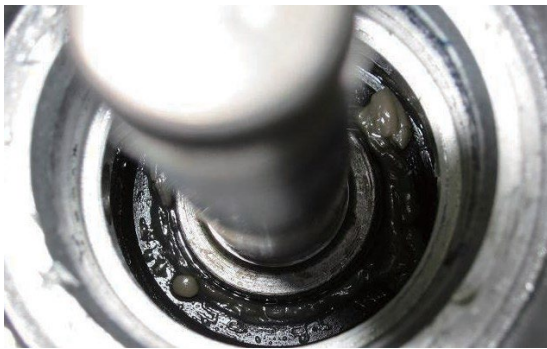
- Coolant leak ⇒ Coolant intrusion into bearing ⇒ Degradation of bearing grease
- Excess belt tension
- Excessive vibration and other unfavorable responses due to fastening failure with mating part, deflection, or unbalance. As a result of excessive vibration, ***fretting** wear occurs to the contact surface and fastening parts (characterized by occurrence of cocoa-colored rust).

(1) Bearing damage (coolant intrusion into bearing)

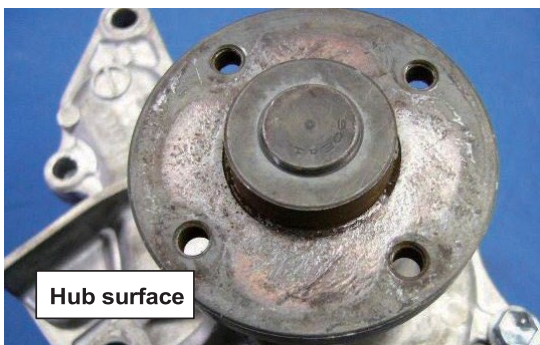
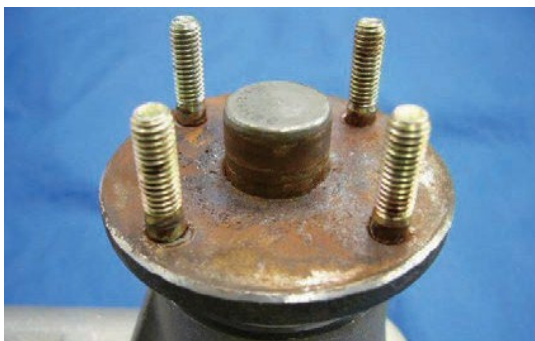
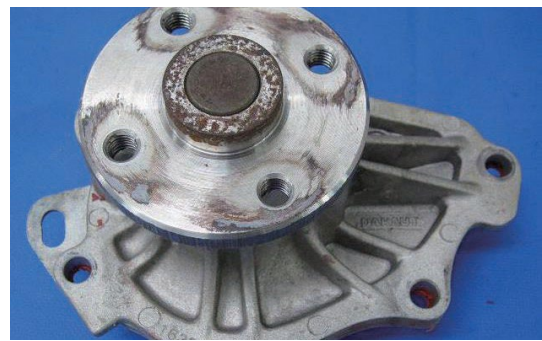
(2) Bearing damage (fretting wear on hub surface and hub axle)

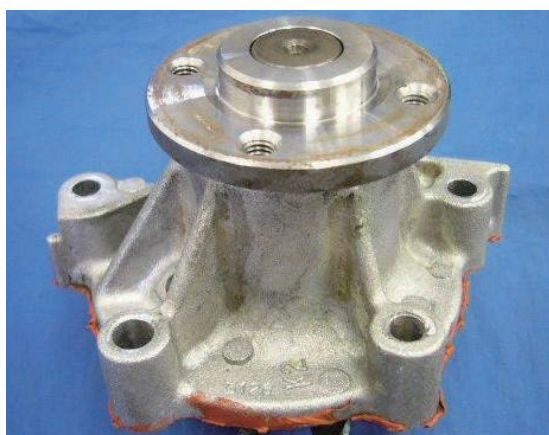
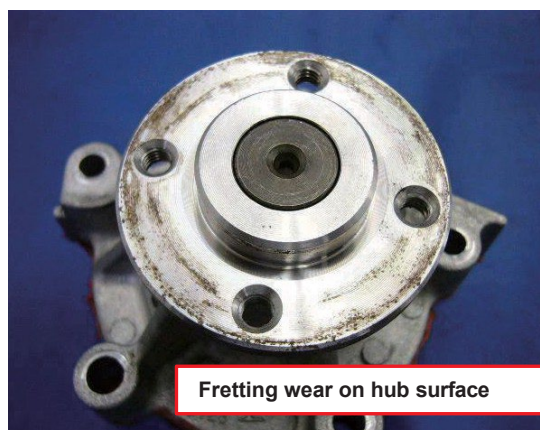
(3) Bearing damage (burns to shaft and ball)

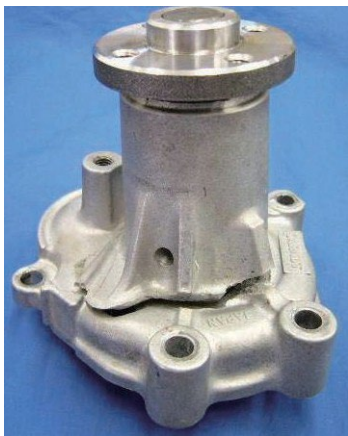
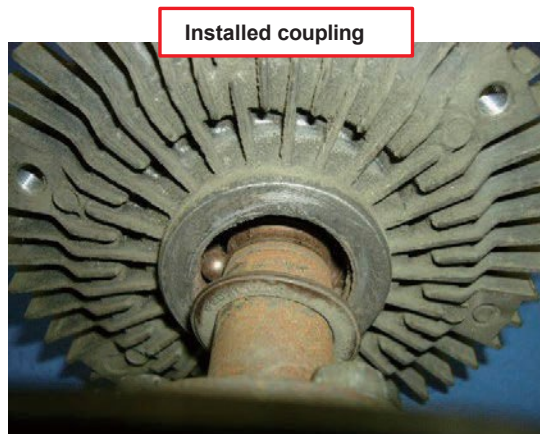
If the use of a defective part is continued, excessive vibration by whirling can damage the pump.

(1) Body damage

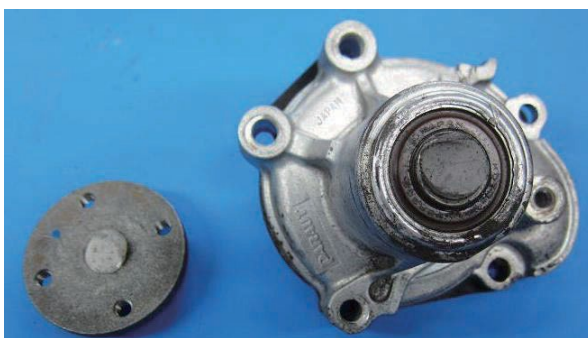
(2) Bearing shaft breakage
